**REPORT OF THE CAPSIZING AND SINKING
OF THE**

M/V J. W. WESTCOTT II

IN THE DETROIT RIVER ON OCTOBER 23, 2001

16700/MC01013409
October 7, 2002

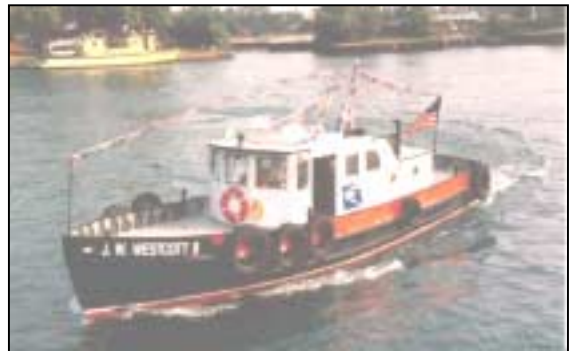
Name:	J. W. WESTCOTT II
Official Number:	258859
Service:	Pilot boat and mail boat
Lifesaving equipment:	14 adult size type V lifejackets
Gross Tonnage:	14
Length:	44.3'
Beam:	13.3'
Draft:	4.5'
Propulsion:	671 Detroit diesel, single screw
Horsepower:	200
Year Built:	1949
Place Built:	Paasche Marine, Erie, Pennsylvania
Home Port:	Detroit, Michigan
Owner/Operator:	J. W. Westcott Company, Foot of 24 th Street, Detroit, Michigan 48222
Master:	Catherine M. Nasiatka Master, 50 GT, Great Lakes and Inland Waters, License #827771 ¹
Crew:	David Lewis Unlicensed

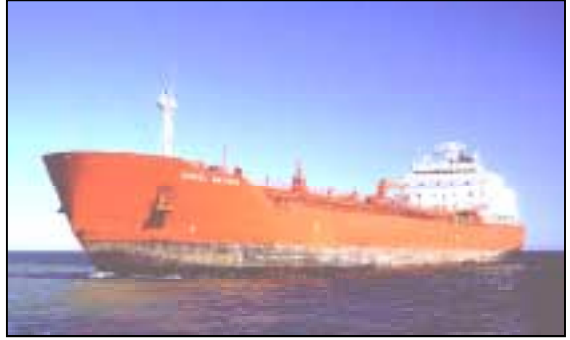
Name: SIDSEL KNUTSEN
 Official Number: L9019779
 Service: Tank ship
 Gross Tonnage: 15806
 Length: 533.2'
 Beam: 75.5'
 Draft: 31.8'
 Propulsion: Diesel electric
 Horsepower: 10,700
 Year Built: 1993
 Place Built: Seville, Spain
 Home Port: Haugensund, Norway
 Owner: Knutsen O.A.S. Shipping, North 5501, P.O. Box 158, Haugensund, Norway
 Operator: Neste OY Shipping, Keilaranta 8, SF-02150 Espoo, Finland
 Master: Jan Holthe
 Pilot: Robert B. Hull, Canadian Great Lakes Pilotage Authority
